UAV for Reliability Build

AEM 4333 – Aerospace Vehicle Design

Abstract

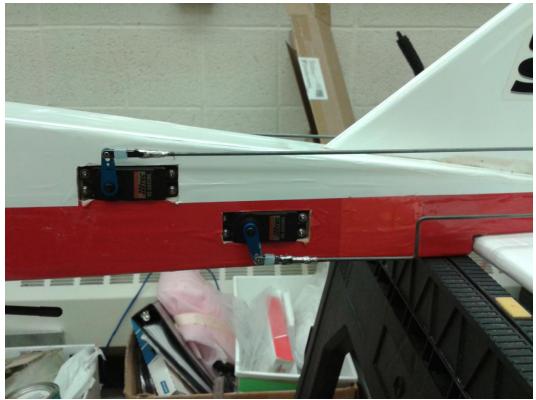
Figure 4: A side view of the tail control surface servos mounted into the fuselage.

The servo on the upper left actuates the rudder and the servo on the lower right actuates the elevator. They are on the same horizontal plane as the servos on the opposite side of the fuselage. There is a gap between the mount locations to ensure that the pushrods will not interfere with each other. They were mounted parallel to the x-axis.

To accommodate the split-tail control surfaces, additional servos were mounted on the fuselage. A side view of the aft section of the fuselage is show in Figure 4.

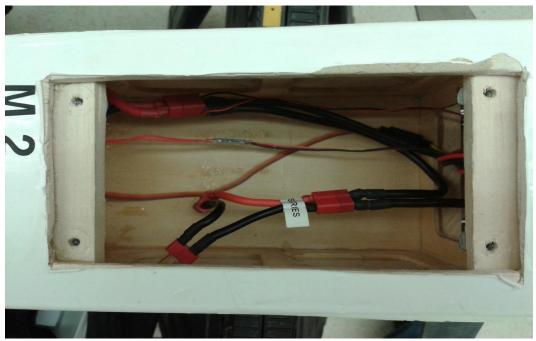
To allow easy access to the internal components that were to be installed, two hatches were cut out from the top wall of the UAV: one near the nose, and the other at the rear of the plane a short distance behind the back of the wing. Four small holes were drilled into the corners of these hatches to allow for screws to secure them down tightly during flight. Two sets of two small, basswood mounting brackets were epoxied to the underside of the fuselage's top wall for mounting each hatch. Corresponding screw holes were drilled into these mounts, and matching T-nuts were installed to allow for the screws to fit securely into metal threads. This is illustrated in Figures 6 and 7 below.

Figure 6: The front hatch cutout in the nose of the aircraft, allowing access to the motor batteries and connecting wires. The wooden mounts and screw holes where the hatches are fastened can be seen on either side of the cutout.

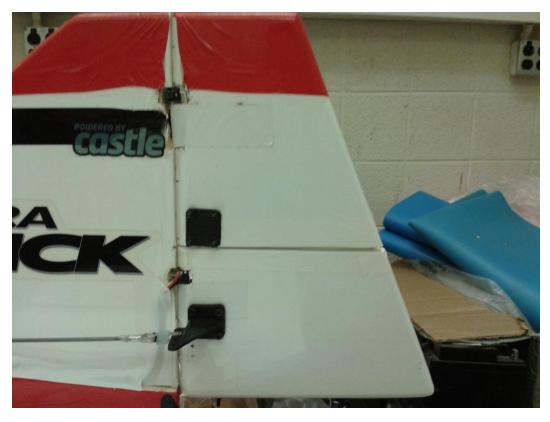
To implement the splitting of the tail control surfaces, a thin-blade, fine-tooth coping saw was used to cut along guides clamped to the rudder, at the location measured and marked based off of the design calculations discussed in the Methods section. The end result is shown in Figure 3. The elevator was cut in a similar fashion, simply continuing the interior angle cut all the way to the rear edge of the horizontal stabilizer, effectively removing a small portion of the spar that had previously joined the two sides of the elevator into one solid piece. This is illustrated in Figure 4. To mount the four rear servos that actuate these split surfaces, two sets of rectangular slots were cut into each side of the rear fuselage. Two basswood rectangular brackets were cut to size and glued with epoxy inside of the rear fuselage. These were used to provide an internal structure for mounting the servos with small wood screws. The basswood mounting brackets had large square slots cut out of their centers to allow for the wires leading to each servo to travel through uninhibited.

Figure 8: A picture of the horizontal cut made to separate the rudder into two separate control surfaces.

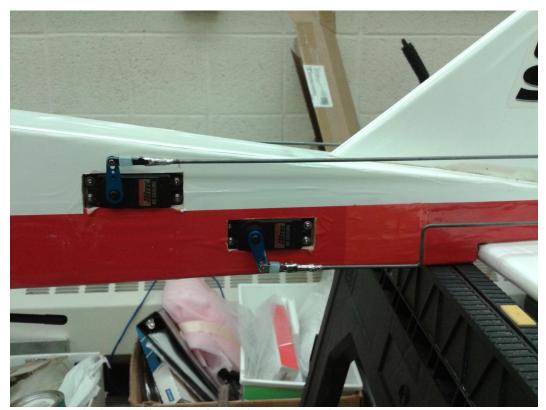
The motor arms of each servo were connected to control pushrods via a metal clevis, illustrated in Figure 10. These clevises were secured to the metal pushrods with solder, and the opposite end of each pushrod was also joined to another clevis with solder. This second clevis was attached to a control horn mounted on each control surface. The entire starboard servo-tail assembly is pictured in Figure 11. The pushrod for the upper rudder is bent twice at 90°. This "stagger" was implemented to account for the difference in height between the top rudder's control horn, and its corresponding servo. This control pushrod was bent this way to ensure that the servo provides actuating force to the top rudder in a direction parallel to the other pushrods. This bent pushrod was reinforced with a diagonal crosspiece made from the same material, and soldered securely in place.

Figure 10: Port servos in the rear of the aircraft, showing the connection between motor arms and the metal clevises soldered onto each pushrod.

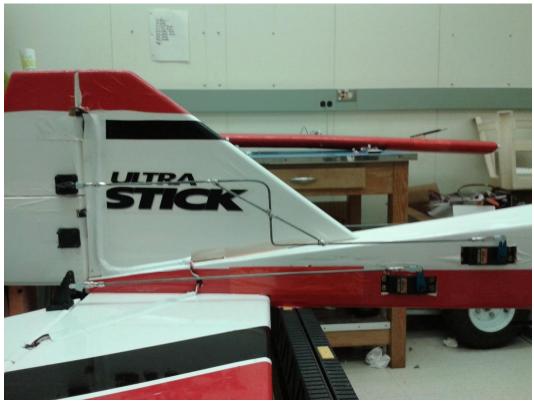
Figure 11: The two starboard control rods used to actuate the right elevator and top rudder. The top control rod is bent to accommodate the height difference between the top rudder control horn and its servo motor arm. The reinforcing diagonal cross piece is also shown.

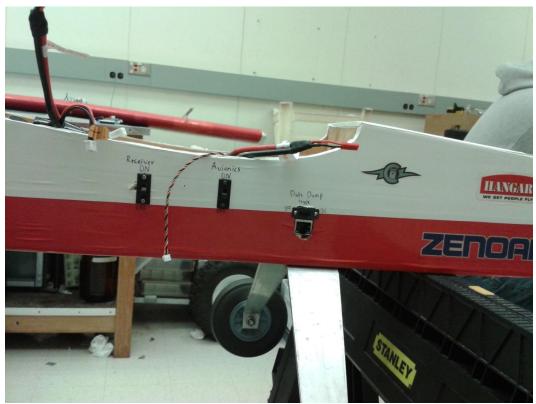
Figure 13: The receiver, avionics, and data dump switches mounted on the outside wall of the aircraft, along with the landing gear bracket.

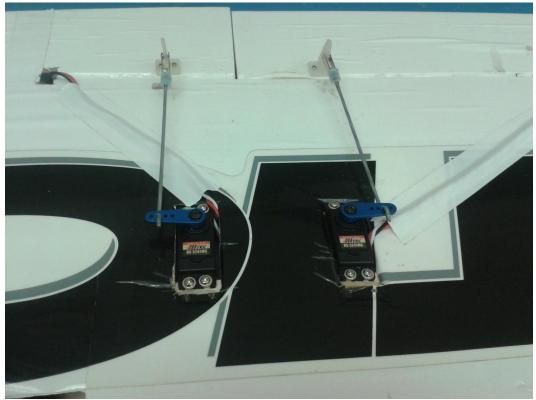
The wing provided for this project was stripped down to the basic structure, with the exception of control surface control horns still present on both ailerons and flaps. While inspecting the wing for damage, it was found that part of the leading edge was "caved in", with a hole also present above it. The perpendicular spars (or "ribs" of the wing) were still intact. A section of MonoKote was cut out around it, and a balsa wood patch was epoxied over the hole. Wood filler was used to reshape this section of the leading edge, and smoothed using sand paper to ensure that it was flush with the rest of the wing. New MonoKote was then placed over top. Small holes in the MonoKote over other areas of the wing were also visible, and were fixed using small MonoKote patches. The four control surfaces in the wing required four servos to be mounted. The existing holes for the placement of the servos were too large for the servos being used. To resolve this problem, small balsa wood rectangles were cut and epoxied to the inside of each hole, effectively making them smaller and allowing the servos to be mounted. Four small wood screws were used to attach each servo. For the wing pushrods, the end near the servo was attached to the servo motor arm with a Z-bend, as opposed to clevises. The other side of each pushrod was still attached to the control horns with the standard clevises, however. One pair of completely-mounted servos on the left side of the wing can be seen in Figure 15.

Figure 15: A pair of wing servos, one used to control the left aileron, and the other used to actuate the left flap.

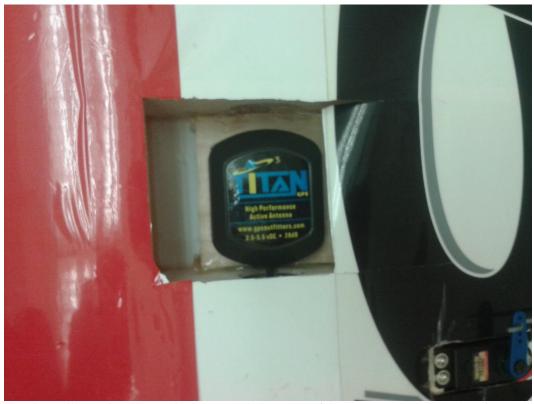
Two other slots in the wing's MonoKote were cut on either side of the wing, between spars. These were the locations for the GPS antenna and the pitot tube mount. To mount the GPS antenna, a thin, rectangular piece of plywood was epoxied between the spars. The GPS antenna was attached with Velcro to the surface of this wooden mount, which will ultimately face the ground during flight. Unfortunately, the GPS antenna needs to be mounted facing the top of the wing, and this problem is discussed later in the Future Plans section. The completed mount is displayed in Figure 16. The long length of wire from the GPS antenna was fed to the other side of the wing internally, through small, pre-existing holes in the wing spars. The excess wire was then coiled up and secured in place in order to properly balance the wing about its center. The pitot tube was mounted in the other slot, cut into the opposite side of the wing.

Figure 16: A picture illustrating the wooden mount and placement of the GPS antenna within the wing.

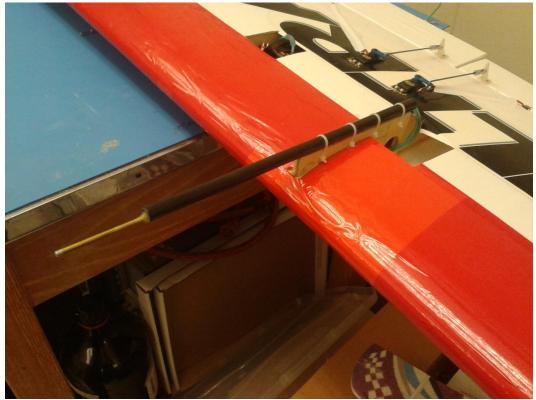
To mount the pitot tube, a piece of plywood was epoxied in place, parallel to the wing spars. The tube itself was placed on top of the edge of this piece, allowing it to sit above the surface of the wing. This was done so that the airflow entering the pitot tube would not be disturbed by the flow around the wing. The actual metal pitot tube was epoxied into the end of a 12-inch-long carbon fiber tube that served as an extension piece, allowing the pitot tube to be placed in front of the wing's leading edge, as seen in Figure 17. This extension tube was zip-tied to the wooden mount using four zip ties. Smaller, flexible tubing attached to the back of the pitot tube was run through the carbon fiber tube and epoxied at the back end of it. These flexible tubes were then fed through the wing to the pressure transducers, located near the center of the wing.

Figure 17: The pitot tube, its carbon fiber extension tube, and the wooden mount used to secure it to the wing. The zip tie connections used to secure the carbon fiber tube to the wooden mount can be seen.

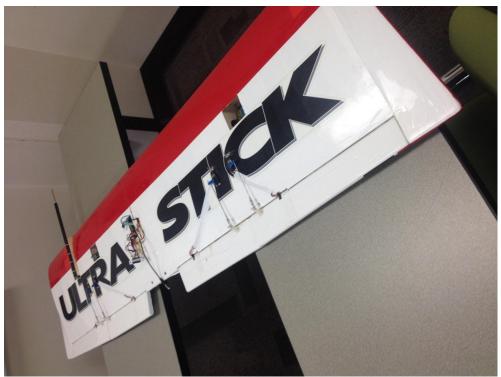
Figure 18: The full wing once completed. The pitot tube mount and the slot for the GPS antenna can be seen, as well as the center hole for all of the wiring meant to connect to the flight computer. The servos and potentiometers attaching to the control surfaces are also visible.
